Breathable Roofing Membranes and Bats: retrospective and proactive measures to prevent death and injury

Summary

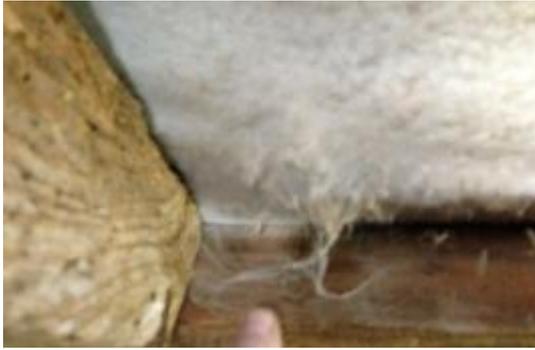
complex roof structure loose fluffed fibres with staining was noted creating an entanglement hazard for the maternity colony of brown long-eared bats (Fig 1).

Fig 1 Fluffing and staining of BRM at Site 1.

The risk of the BRM to bats was discussed with the owner. Due to the time of the year, a quick response solution was required prior to the return of the maternity colony. Netlon® mesh type XN1455-8002 was used to cover all exposed areas of BRM from inside the one roof void. The mesh was fastened using staples to wooden roof timbers, taking approximately one week to complete. Staples were placed close to each other to prevent bats from becoming trapped between the BRM and the mesh. A recommendation to carry out a more long-term fixing of the mesh post-maternity season was recommended using battening. A follow up visit on the 30 June 2014 identified the continued use of the roost by brown long-eared bats, with approximately ten individuals recorded (Fig 2).

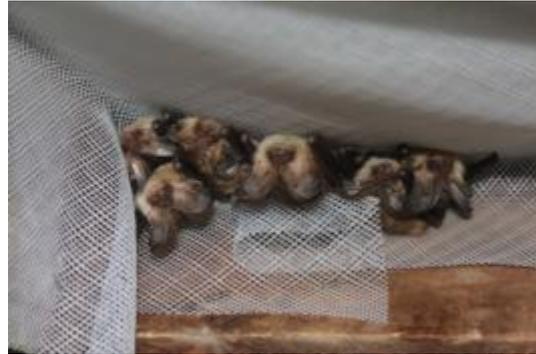
Fig 2 Brown long-eared colony roosting on Netlon® mesh (without battens) over BRM at Site 1.

The brown long-eared maternity colony at Site 1 was recorded to continue to use the roof space following the installation of Netlon® mesh. Whilst this method of intervention demonstrates a valid response to protect a bat roost from incidental death and injury, a number of potential concerns have been raised. Firstly, it is of paramount importance that the mesh is preferably fixed with battens. Where staples are used as a quick fix they must be positioned close together to prevent bats from crawling between the mesh and BRM which

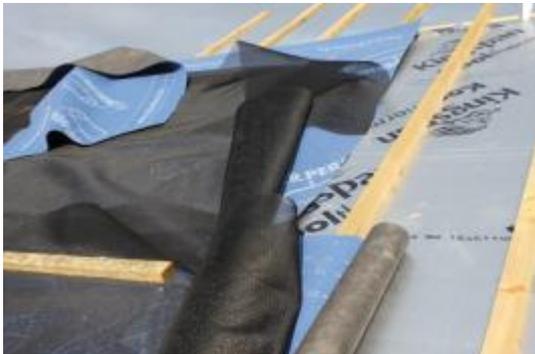
The use of BRM on the roof of the barn during the conversion process was interrupted in April 2014 by an ecological consultant when BRM had been battened to the roof and approximately 20% of the re-tiling had been completed. The roof construction included the use of chipboard, insulation, battening, BRM, cross battening and roof tiles. Therefore, the removal of the existing membrane would have caused significant increases in project costs and delays to the completion deadline. In this case, the identified risk was the future potential for individual/small numbers of bats roosting under roof tiles to become entangled within the BRM in the future. Netlon® mesh type XN1081-8000 was used to cover the remainder of the BRM over the cross battening during the installation process and prior to the fixing of the remainder of the roof tiles (Fig 3 and 4).

Fig 3. Overlaying the Netlon® onto the BRM at Site 2 as part of the re-roofing works.

The solution delivered on Site 2 is expected to have a mitigating effect in protecting any future use of the building by bats, particularly potential roost spaces under roof tiles.

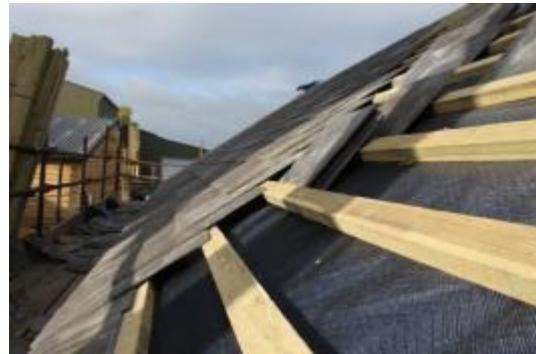
Fig 4. Overlaying battens and tiles over the Netlon® as part of the re-roofing works at Site 2.

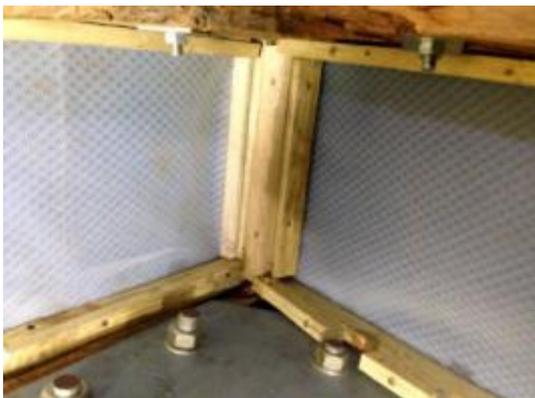
Only a partial area of the total roof space was subject to works. The roof void required the installation of fire doors together with minor ridgeline re-tiling. An inspection survey of the roof void undertaken 4 July 2014 revealed four brown long-eared bats including a juvenile. Additionally, the presence of BRM was identified within the roof void. The BRM was covered by sarking boarding exposing <10mm of the BRM underneath or was covered in traditional bitumen felt in most areas, with the exception of one small roof pitch where the BRM was fully exposed.

Fig 5. Overlain Netlon® with battens onto the BRM at Site 3.

Netlon® mesh type XN1455-8002 was used to cover over the internally exposed BRM, fixed with battening (Fig 5).

Site 3 provides an example of proactive temporary solution to the use of BRM in a roof void where future risk is identified. The application of the Netlon® together with the battens provides a neat finish which doesn't present any potential gaps which could allow bats to crawl through to the BRM.
